How Severn's intelligent OEM retrofit extended control valve life at Berri Junction

# Engineering control valves to handle black powder duty

Berri junction (Jubail)  
Saudi Arabia

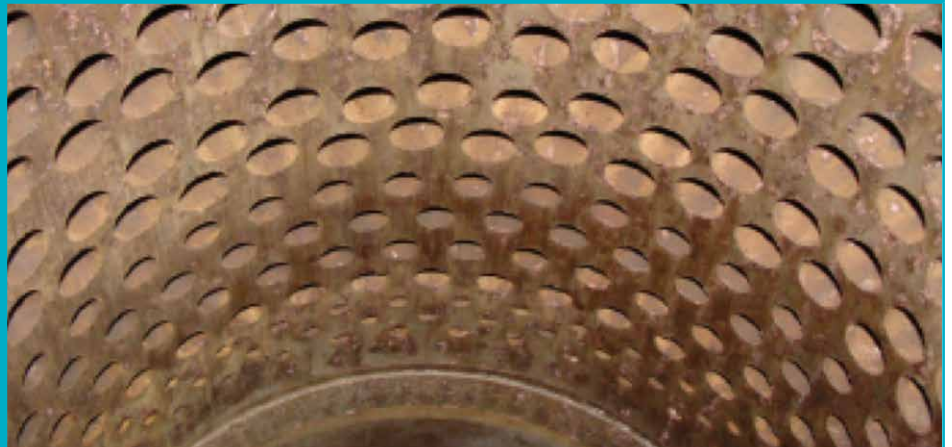
### INNER CAGE

Excellent condition with no erosion or degradation. Some black powder was lodged in the holes above the active part of the trim, however it was loosely packed and disintegrated when disturbed.

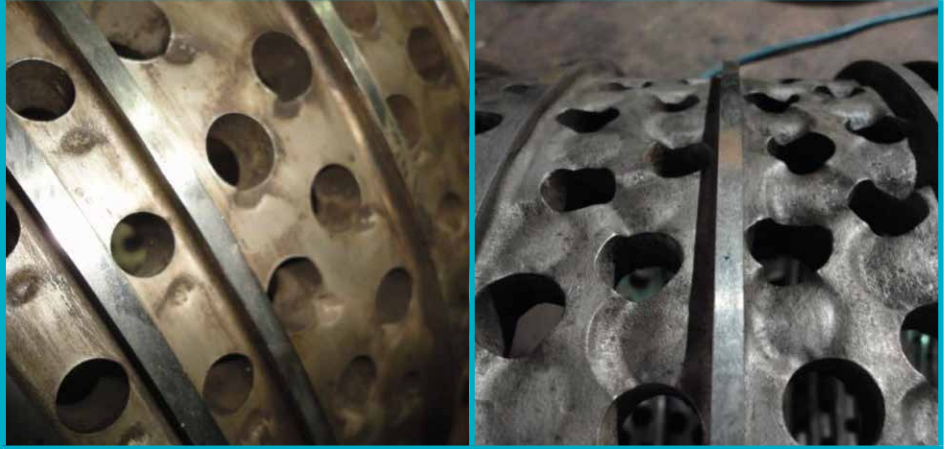
### OUTER AND MID CAGES

There was evidence of some erosion on both components, but not significant enough to be detrimental to the operation or structural integrity of the cages or their assembly.

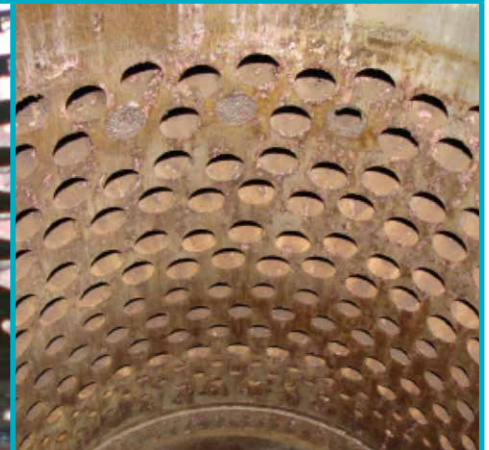
### AFTER 5 YEARS

**After five-and-a-half years of uninterrupted service, Saudi Aramco needed to install higher capacity valves and the retrofitted valves were made available for inspection. The following observations were made of the three-cage assembly:**

- ✔ Use of hard materials such as Tungsten Carbide in a combination suited to application characteristics.
- ✔ When component size or cost parameters prevented the use of solid Tungsten Carbide, a thick Tungsten Carbide cladding was used. This provides far superior erosion resistance to sprayed Tungsten Carbide coatings typically used for anti-galling in ball valve applications.
- ✔ Mechanical containment of the hard, relatively brittle components.
- ✔ Control of velocity levels and flow geometry through the trim and the valve body at magnitudes capable of sustaining capacity while reducing the erosion rate. Channelling high velocity media through a tortuous path results in better management of its erosive energy and is only achievable with a globe style valve design.
- ✔ New low failure rate manufacturing processes for the large Tungsten Carbide parts.

The trim materials were a variation of Severn's Level 3 erosion resistant trim. Tungsten Carbide components made up the throttling and erosion risk areas whilst other materials of proven durability combined to ensure the five-year warranted operational life was met and exceeded. Valve design and material selection were underpinned by knowledge of actual valve performance, which was fed into the process to create a continuous improvement cycle.
